Pyro Mi Fire Survival cable

INSTALLATION RECOMMENDATION FOR REPAIRS TO LSF COVERED PYRO MI WIRING CABLES - DAMAGED DURING INSTALLATION

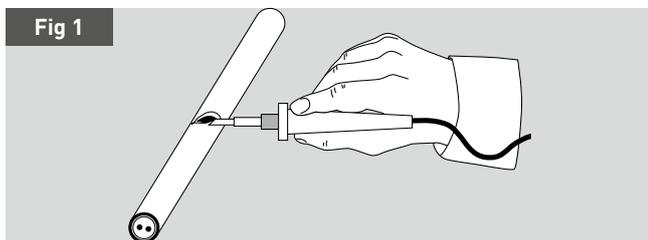
For minor repairs, the LSF material adjacent to the damage can be re-moulded. This is achieved by using an electric soldering iron or a hot knife to melt the material and redistribute it (Fig 1). The soldering iron is the most convenient, as it remains hot in use. More extensive damage will necessitate the use of a larger soldering iron. Areas of major damage can be repaired by neatly cutting out the damaged section and replacing it with a new piece cut from a surplus piece of cable. The new piece is moulded into place by heating the joint seams as previously described.

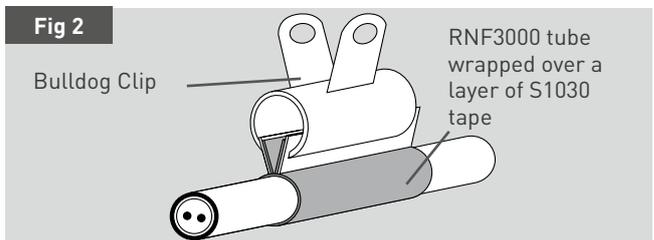
It is best to apply the tube intact by sliding it on from one end of the cable, however, if the cable is installed, this may be difficult. In these circumstances the tube may be split longitudinally to form a plastic sheet.

This is then wrapped around the layer of S1030 tape and held in place with a bulldog clip (Fig 2). Heat is then applied. Do not allow

the tube to pull out of the bulldog clip. When the adhesive has melted, the repair is allowed to cool before removing the bulldog clip.

The excess flash is then carefully cut off.
